Storm Water Facility Inspection/Site Visit Report Form

Job Address 1820 S RESERVOIR

Stormwater Inspection 1820 S Reservoir St Pomona, California

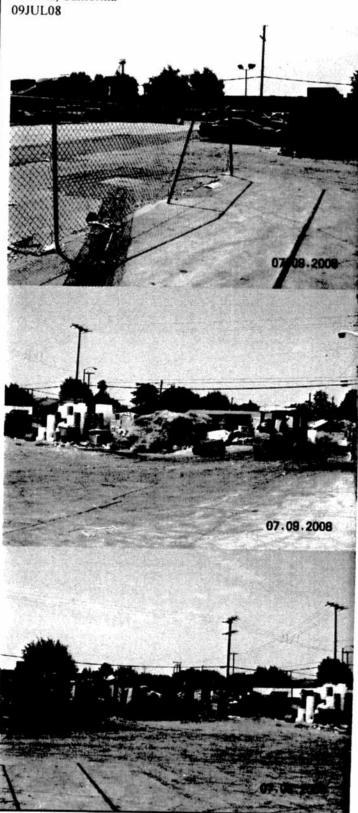
PHOTOGRAPH 1.

View of the fence along the W side of the facility.

The tenant was instructed to increase the fence length to touch the ground and place screen at the bottom to catch wind-blown debris. Tenant was also instructed to clean out gutter and place screen over gutter to prevent debris entering storm drain.
